CHAPTER 53 — FUSELAGE

FUSELAGE

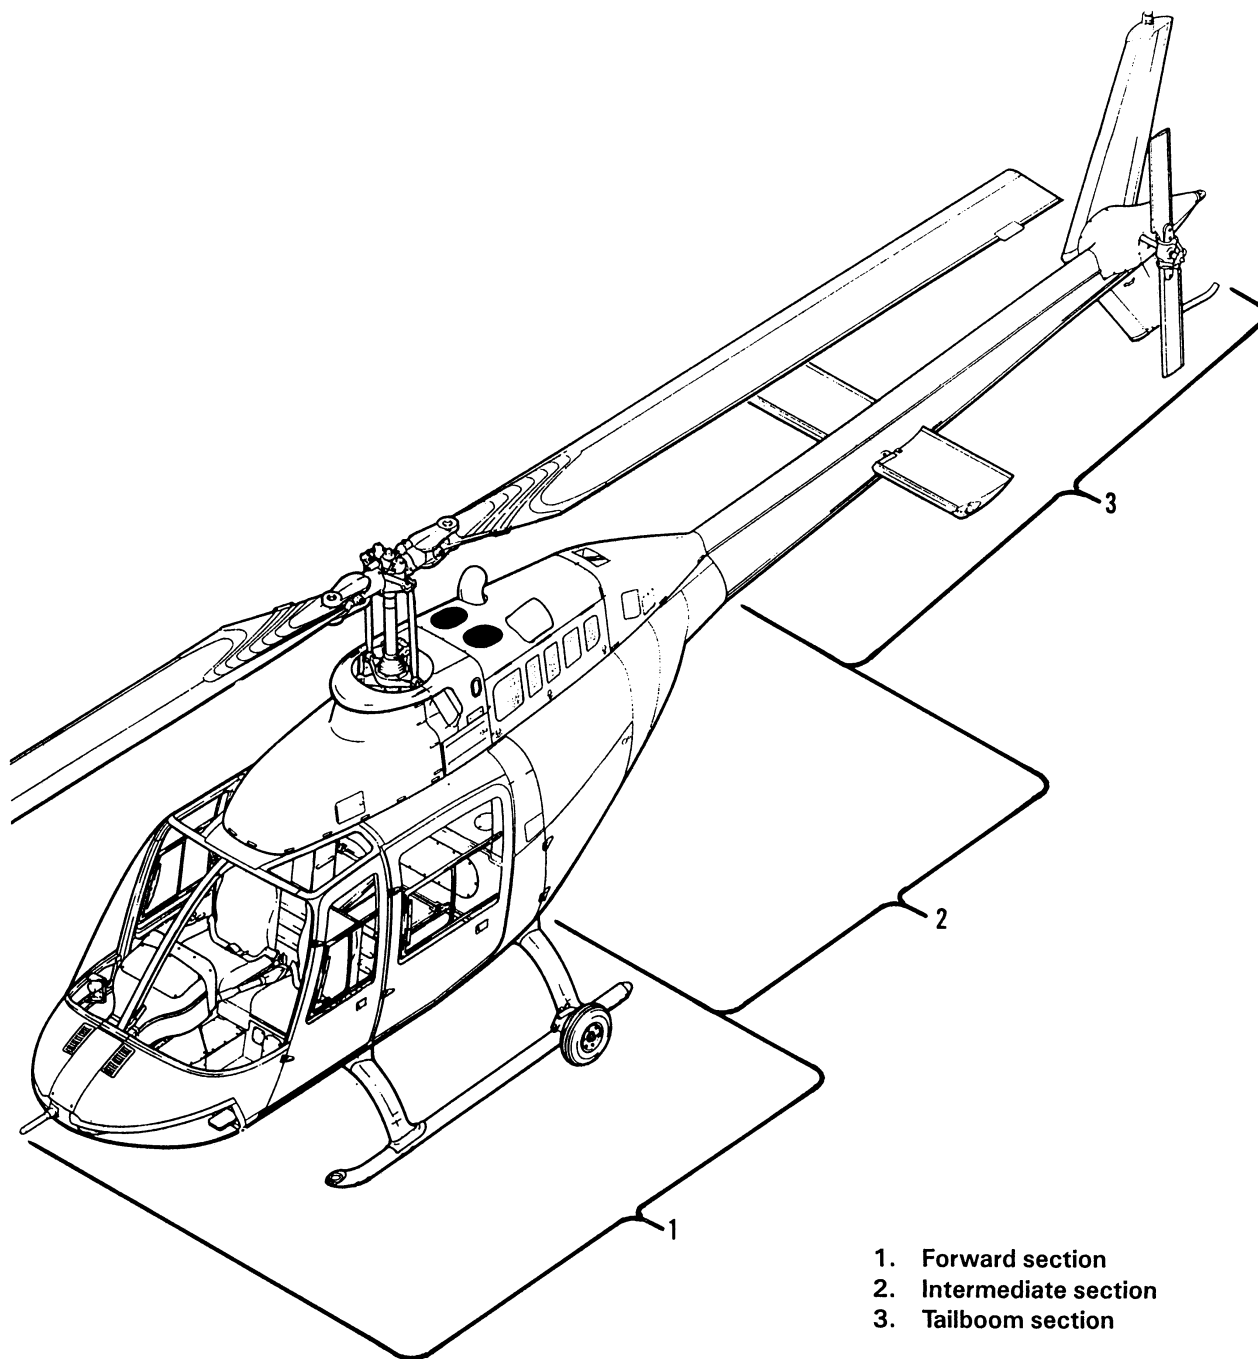
Figure 53-1. Fuselage Assembly

The fuselage consists of three main sections: the forward section (1, [Figure 53-1](#)) which extends from cabin nose to bulkhead aft of passenger compartment, intermediate section (2) which extends from the bulkhead aft of passenger compartment to tailboom attach and tailboom section (3).

The intermediate section utilizes an aluminum semimonocoque construction and provides a deck for engine installation, a baggage compartment and a compartment under the engine deck for heater and electrical equipment.

To ease identification of the 206A/B vertical fins (1), they have been categorized into three types. Please refer to [Table 53-3](#) and the associated notes as well as [Figure 53-4](#) to identify the vertical fins (1, [Figure 53-1](#)).

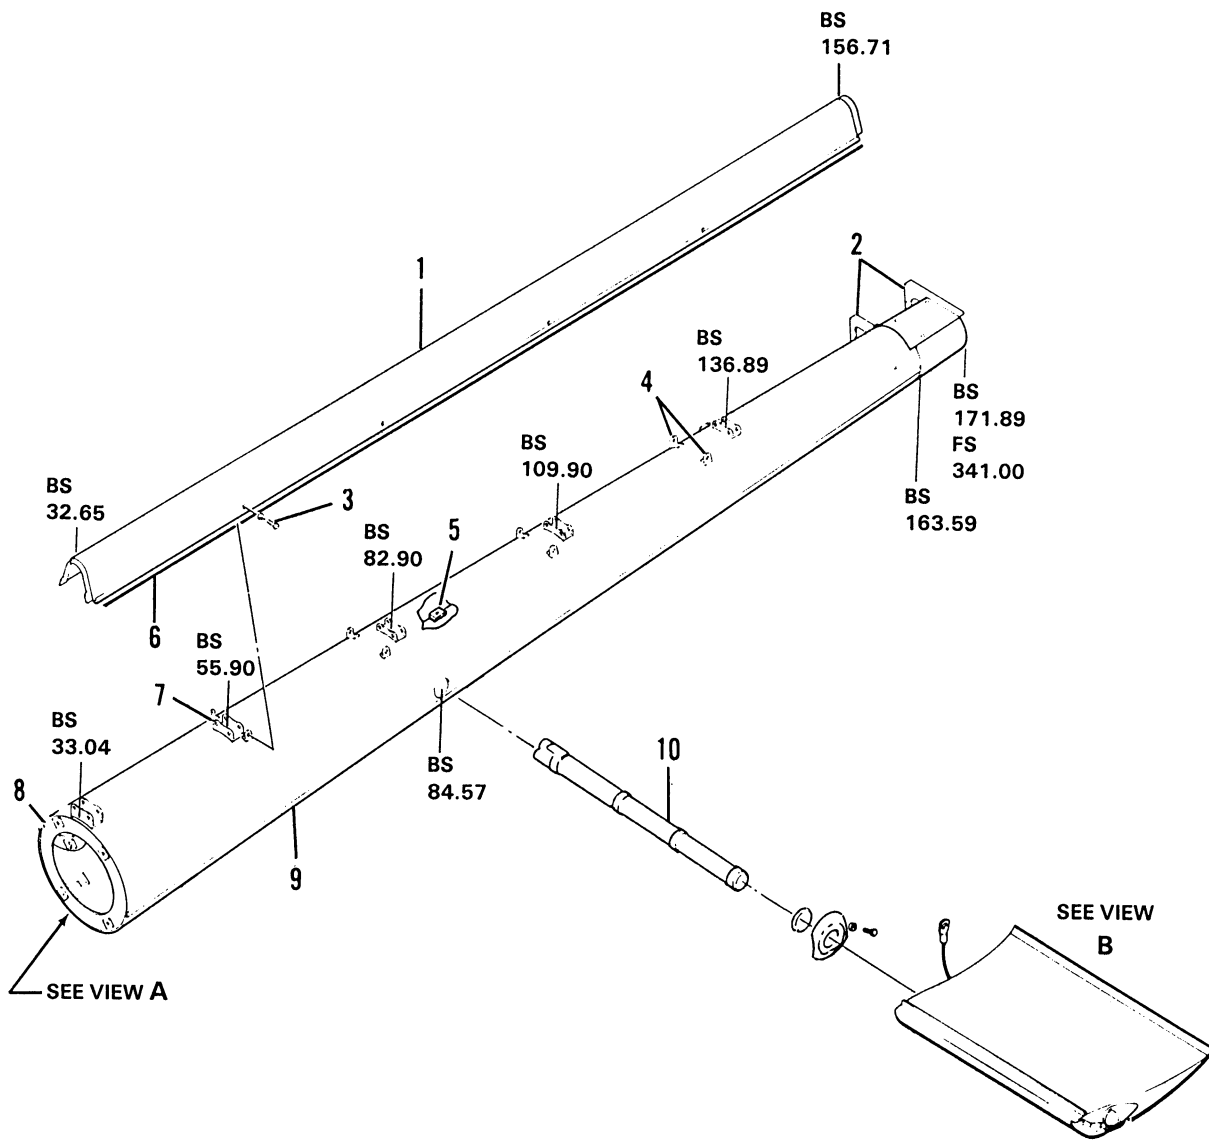
Figure 53-2. Tailboom and Horizontal Stabilizer (Sheet 1 of 3)

1. Remove access door from right side of fuselage just forward of bulkhead (8, [Figure 53-2](#)).
2. Disconnect studs (3) from clips (4) on both sides of tail rotor driveshaft cover (1). Remove cover from tailboom (9).
3. Remove aft engine fairing ([Chapter 71](#)).
4. Position left tail rotor control pedal full forward and disconnect tail rotor control tube just forward of bulkhead (8) in aft fuselage ([Chapter 67](#)).

7. Support tailboom (9) and remove nuts (15) and steel washers (14) from four attaching bolts (12) ([Figure 53-2](#), Section A-A). Remove four bolts (12) and four chamfered washers (13) from aft fuselage and tailboom (9).

1. Inspect tailboom (9, [Figure 53-2](#)) at attached points on canted bulkhead and fuselage frame for cracks, damage and corrosion.
2. Inspect four tailboom-to-fuselage attaching bolt holes in tailboom and fuselage fitting for elongation. Maximum diameter is 0.391 inch (9.931 mm). Ensure four shims (11) are bonded in place.

3. Inspect bolts (12) and nuts (15) for damaged threads or any indication of damage. Replace as necessary.

8. Total damage to tailboom (9) must not exceed 5% of tailboom area, approximately 160.0 square inches (1032.0 cm²).

1. Position tailboom (9, Figure 53-2) against aft fuselage and place suitable supports at each end of the tailboom.

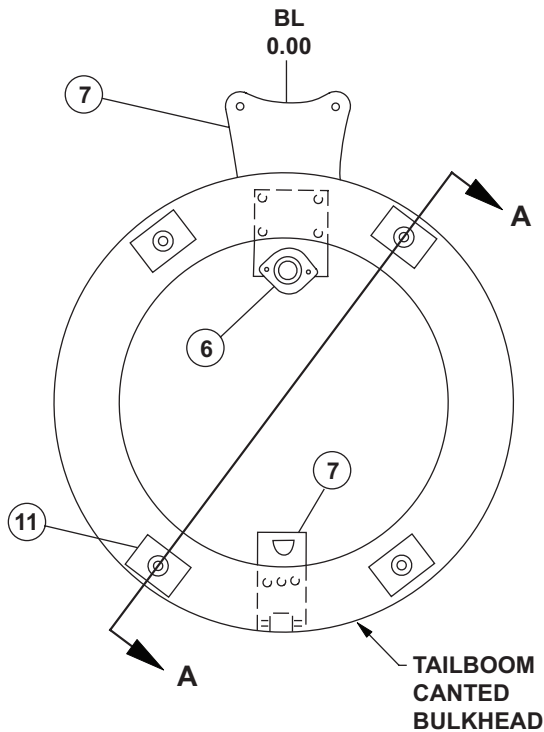
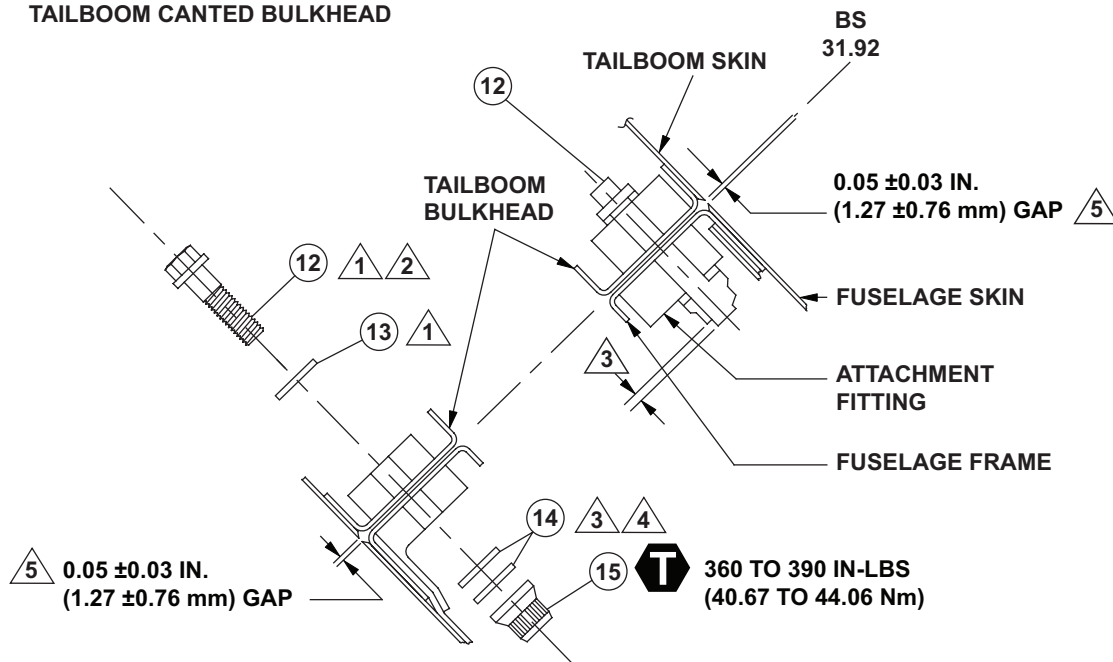
Figure 53-2. Tailboom and Horizontal Stabilizer (Sheet 2 of 3)

VIEW A
VIEW LOOKING AFT
TAILBOOM CANTED BULKHEAD

- 1 External wrenching bolts (12) and countersunk washers (13) are to be installed through tailboom and fuselage. Bolt heads are to be on tailboom side with washer countersink next to bolt heads.
- 2 Apply a coating of corrosion preventive compound (C-104) to all bolt shanks prior to installation. Do not apply corrosion preventive compound to bolt threads.
- 3 Steel washers (14) are to be installed as required under the nut (15) to provide not less than one complete thread and not more than three complete threads exposed on the end of the bolts (12).
- 4 A minimum of one steel washer (14) is required under the nut (15).
- 5 A gap between the tailboom canted bulkhead and the fuselage results from four shims bonded to the forward face of the tailboom canted bulkhead.

SECTION A-A
BOLT INSTALLATION

2. Align tailboom canted bulkhead (8) and fuselage frame attachment holes (Figure 53-2, View A, Section A-A).

14. Do a torque check of tailboom attaching nuts (15, Figure 53-2, Section A-A) 100 flight hours after each installation (Chapter 5).

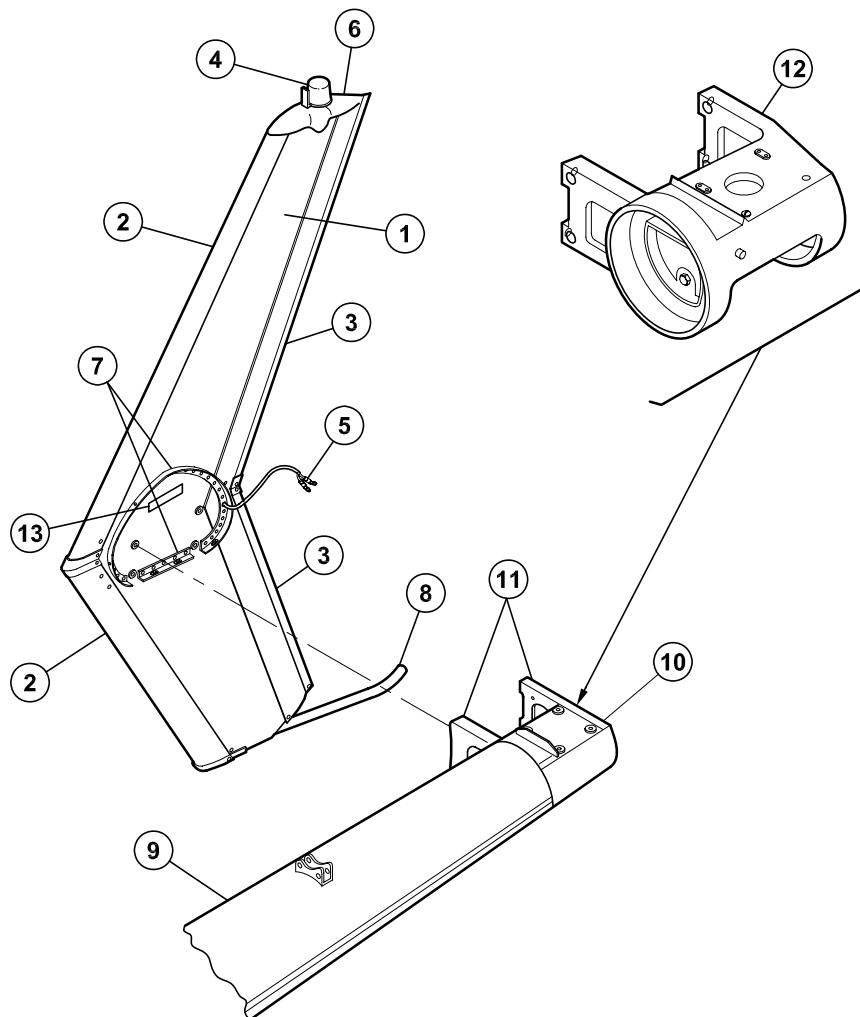
Figure 53-3. Vertical Fin Assembly

The vertical fin (1, [Figure 53-3](#)) is an aerodynamic surface that gives stability to the helicopter while it is in flight. The vertical fin (1) is installed with the leading edge positioned outboard (with reference to the aircraft longitudinal axis). This helps to unload the tail rotor while the helicopter is in forward flight. The vertical fin (1) is made up of an aluminum honeycomb core with aluminum outer skins. The leading and trailing edge caps (2 and 3) are made of formed aluminum alloy. The anticollision light (4) is installed on the upper fairing (6) of the vertical fin. The rubber bumper and the tail skid (8) are bonded into the base of fin. The tail skid (8) absorbs shock in the event of a tail low landing ([Chapter 32](#)).

1. Vertical fin (typical)
2. Leading edge caps
3. Trailing edge caps
4. Anticollision light
5. Anticollision light wiring
6. Upper fairing
7. Fairing formers
8. Tail skid
9. Tailboom
10. Sheet metal tailrotor gearbox support
11. Two-piece attachment supports
12. One-piece tail rotor gearbox support casting
13. Identification tag

Vertical fins (1, [Figure 53-3](#)) have been produced or field modified with various configurations of external skins and doublers. These vertical fins (1) can also be attached to the helicopter with two types of attachment supports (11 and 12) ([paragraph 53-13](#)). As the various combinations of vertical fins (1) and attachment supports (11 and 12) require differing inspection and installation procedures. The following information will ensure that you can identify the vertical fin (1) used on your helicopter.

The vertical fin identification tag (13) can be found on the inboard skin in the area above the four inserts that mate with the attachment supports (11 and 12).

The vertical fins identified in [paragraph 53-12](#) may be attached to the tailboom with two different types of attachment supports. The two types of attachment supports include a two-piece attachment support (11, [Figure 53-3](#)) used in conjunction with a sheet

metal tail rotor gearbox support (10), or a one-piece tail rotor gearbox support casting (12). As the various combinations of vertical fins and attachment supports require differing inspection and installation procedures, the following information will ensure that you can identify the attachment support installation used on your helicopter.

8. Inspect the vertical fin (1, [Figure 53-3](#)) and the supports (11 or 12) with the vertical fin removed as follows:

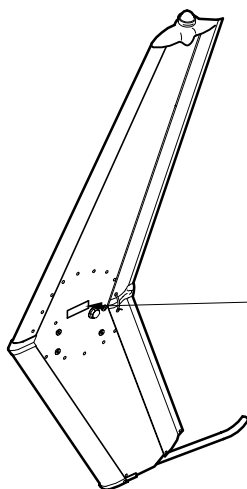
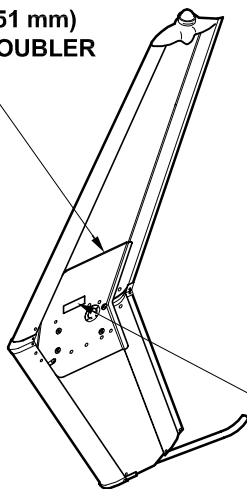
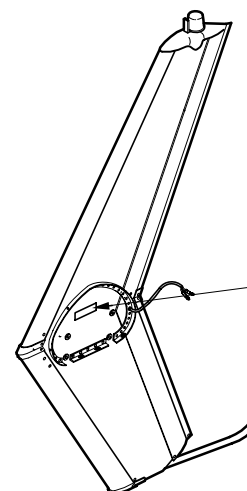
Figure 53-4. Vertical Fin Identification

TYPE 1 VERTICAL FIN

Type 1 vertical fins have a 0.040 inch (1.02 mm) thick inboard skin.
(Pre Service Letter SL 206-203).

TYPE 2 VERTICAL FIN

Type 2 vertical fins have a 0.040 inch (1.02 mm) thick inboard skin and a 0.020 inch (0.51 mm) thick external doubler installed on the inboard skin (Post Service Letter SL 206-203).

TYPE 3 VERTICAL FIN

Type 3 vertical fins have a 0.063 inch (1.60 mm) thick inboard skin.

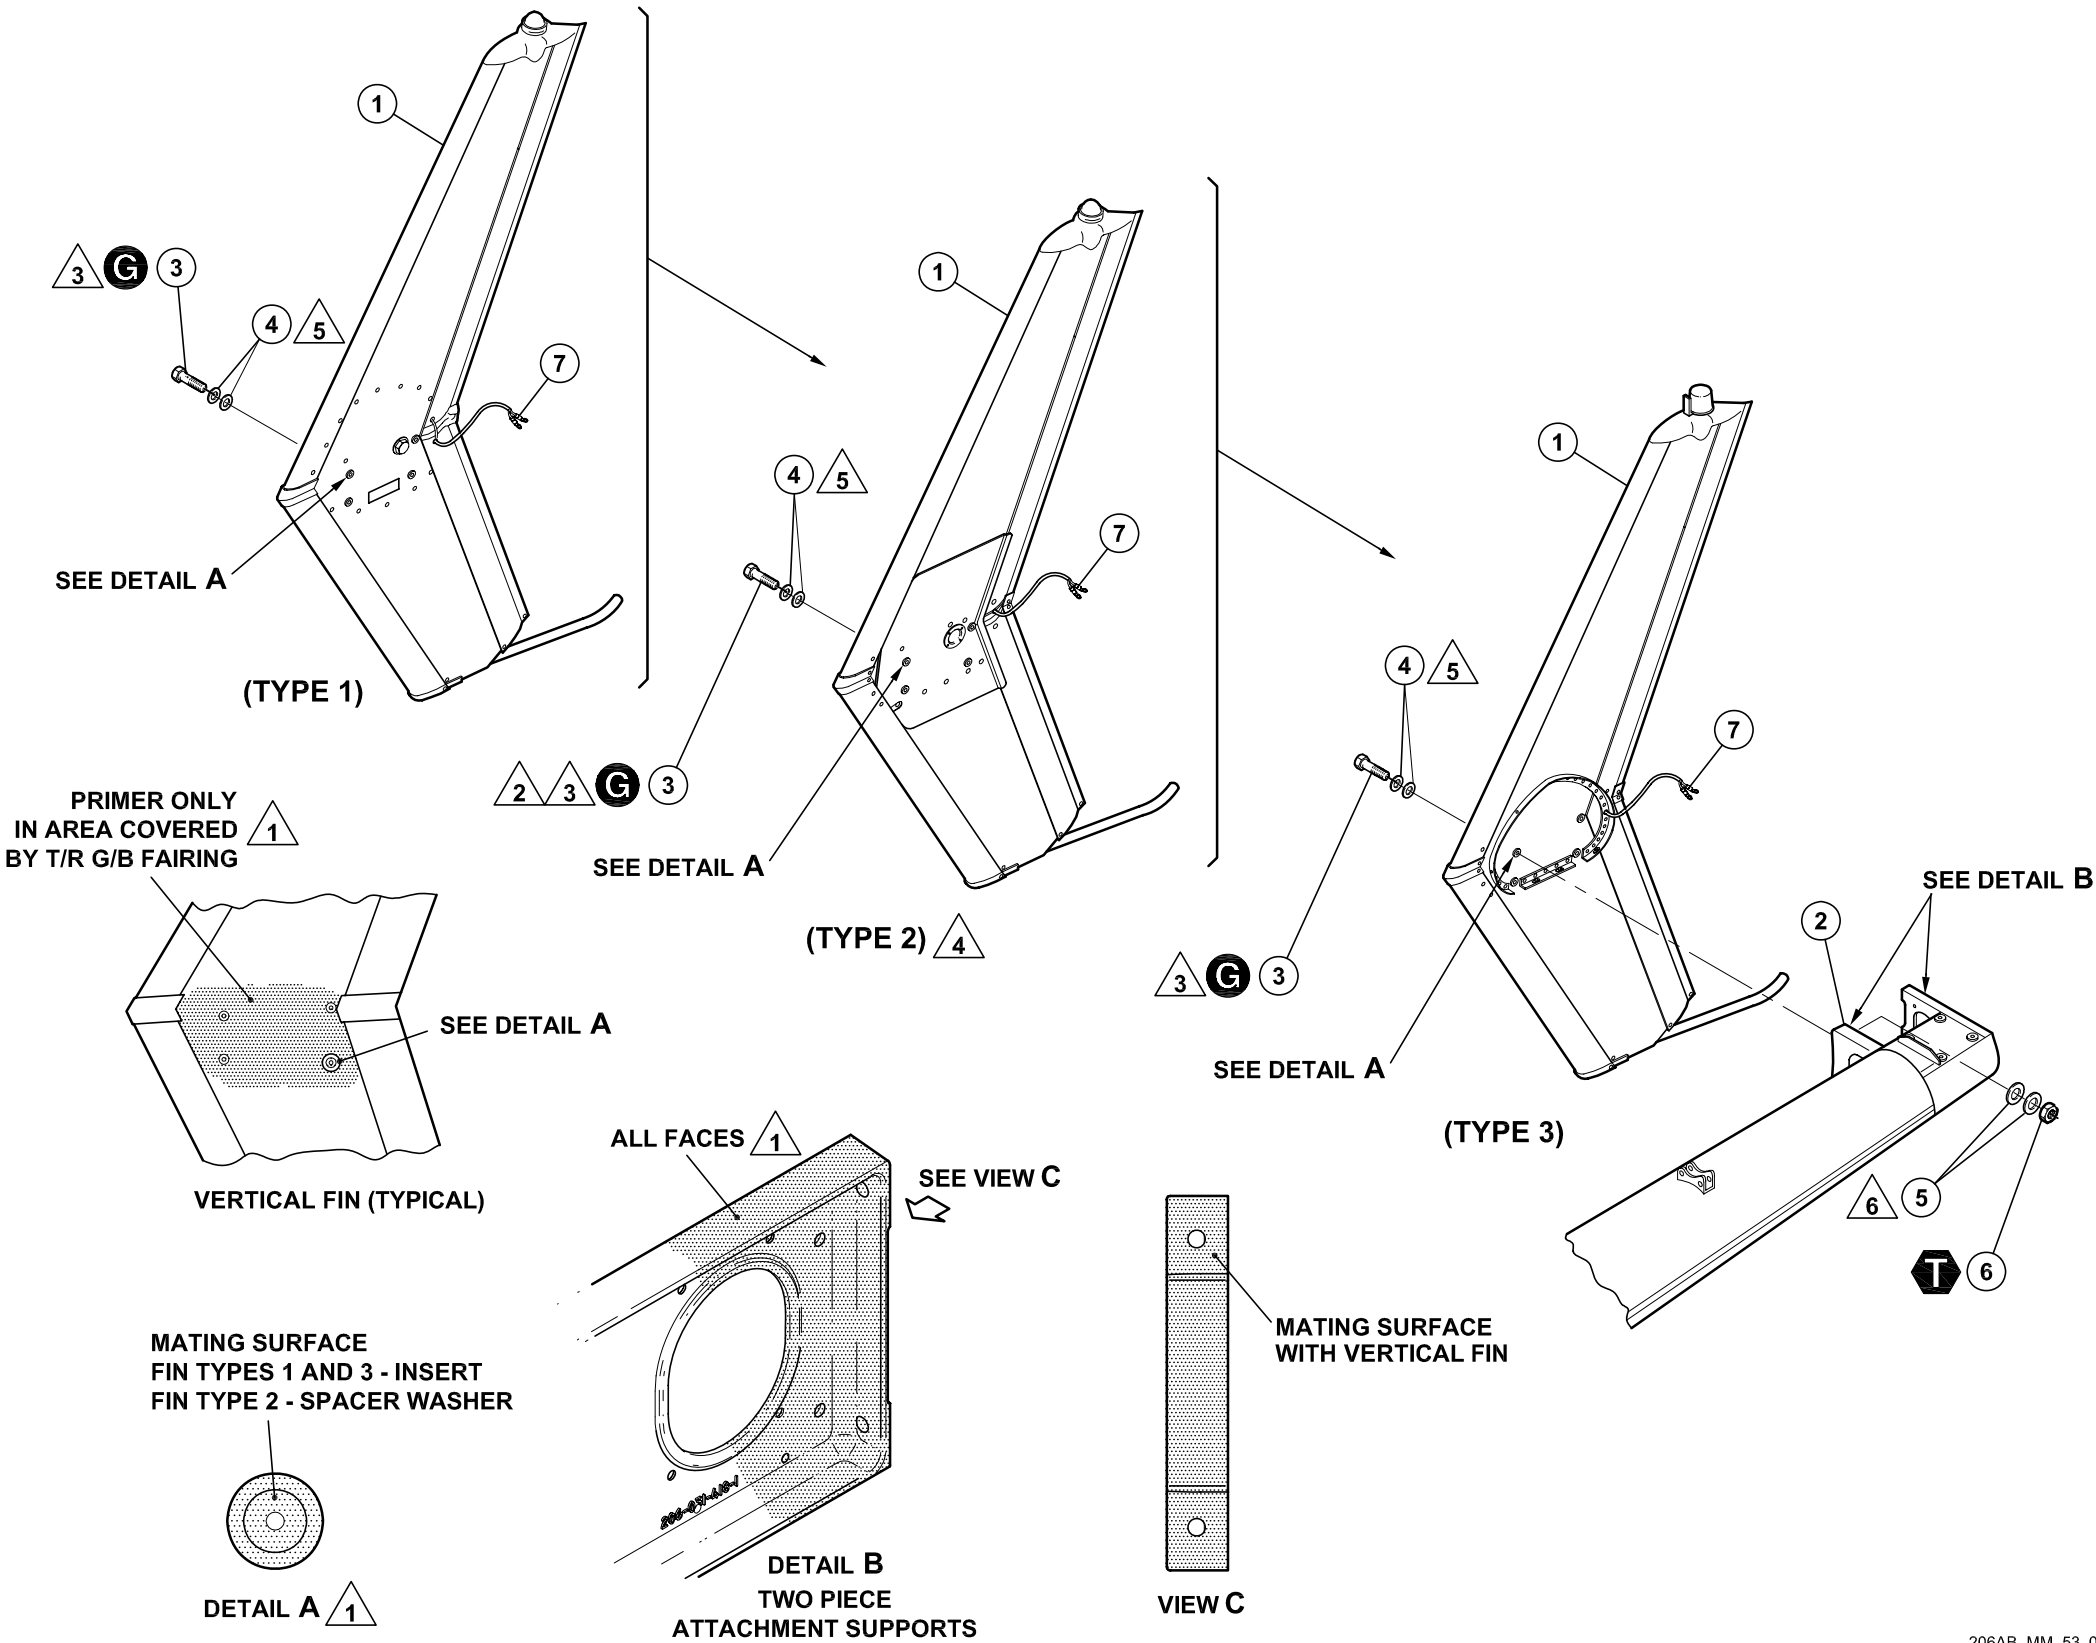
Figure 53-5. Vertical Fin Attachment to Two-Piece Supports

4. Remove vertical fins (1, [Figure 53-5](#)) installed on two-piece attachment supports (2) as follows:
 - a. Disconnect the anticollision light wiring (7). Insulate and stow wires to prevent damage.
 - b. Hold the vertical fin (1).
 - c. Remove nuts (6) and radius washer(s) (5).
 - d. Remove the bolts (3) and washers (4).

- e. Remove vertical fin (1, [Figure 53-5](#)) from supports (2).
 - f. Put the vertical fin (1) on a soft surface to prevent damage.
5. Remove vertical fins (1, [Figure 53-6](#)) installed on one-piece support casting (2) as follows:
- a. Disconnect the anticollision light wiring (7). Insulate and stow wires to prevent damage.
 - b. Hold the vertical fin (1).
 - c. Remove bolts (3) and washer(s) (4).

Surfaces to have primer coating only. There shall be no paint coating.
2. When installing Type 2 vertical fins only, bolts NAS6604-27 may be used as an alternate to NAS1304-26 /NAS6604-26 to permit proper grip and thread engagement.
3. Apply a coating of corrosion preventive coating (C-104) to shank of bolts prior to installation. Do not apply corrosion preventive coating to threads of bolts.
4. When installing Type 2 fins only, ensure spacer washers are bonded to fin (4 places) prior to installation of fin. refer to Figure 53-8.
5. A quantity of two washers (3) are required for each location.
6. To permit proper thread engagement, install a minimum of 1 / maximum of 2 radius washers (5) between supports (2) and nuts (6) (4 locations).

a. For vertical fins (1, [Figure 53-5](#)) installed on two-piece attachment supports (2), ensure nuts (6) have a minimum torque check value of 75 inch-pounds (8.47 Nm).

c. If the torque check on all fasteners specified in [step a](#) or [step b](#) is in accordance within the minimum required value, do a visual inspection of the supports (2, [Figure 53-5](#) or [Figure 53-6](#)) in the area of the vertical fin attaching hardware and in the radius areas of the supports. Inspect for cracks, looseness, corrosion and other damage. If an attachment support crack is suspected, remove the vertical fin ([paragraph 53-14](#)) and complete [step 8](#).

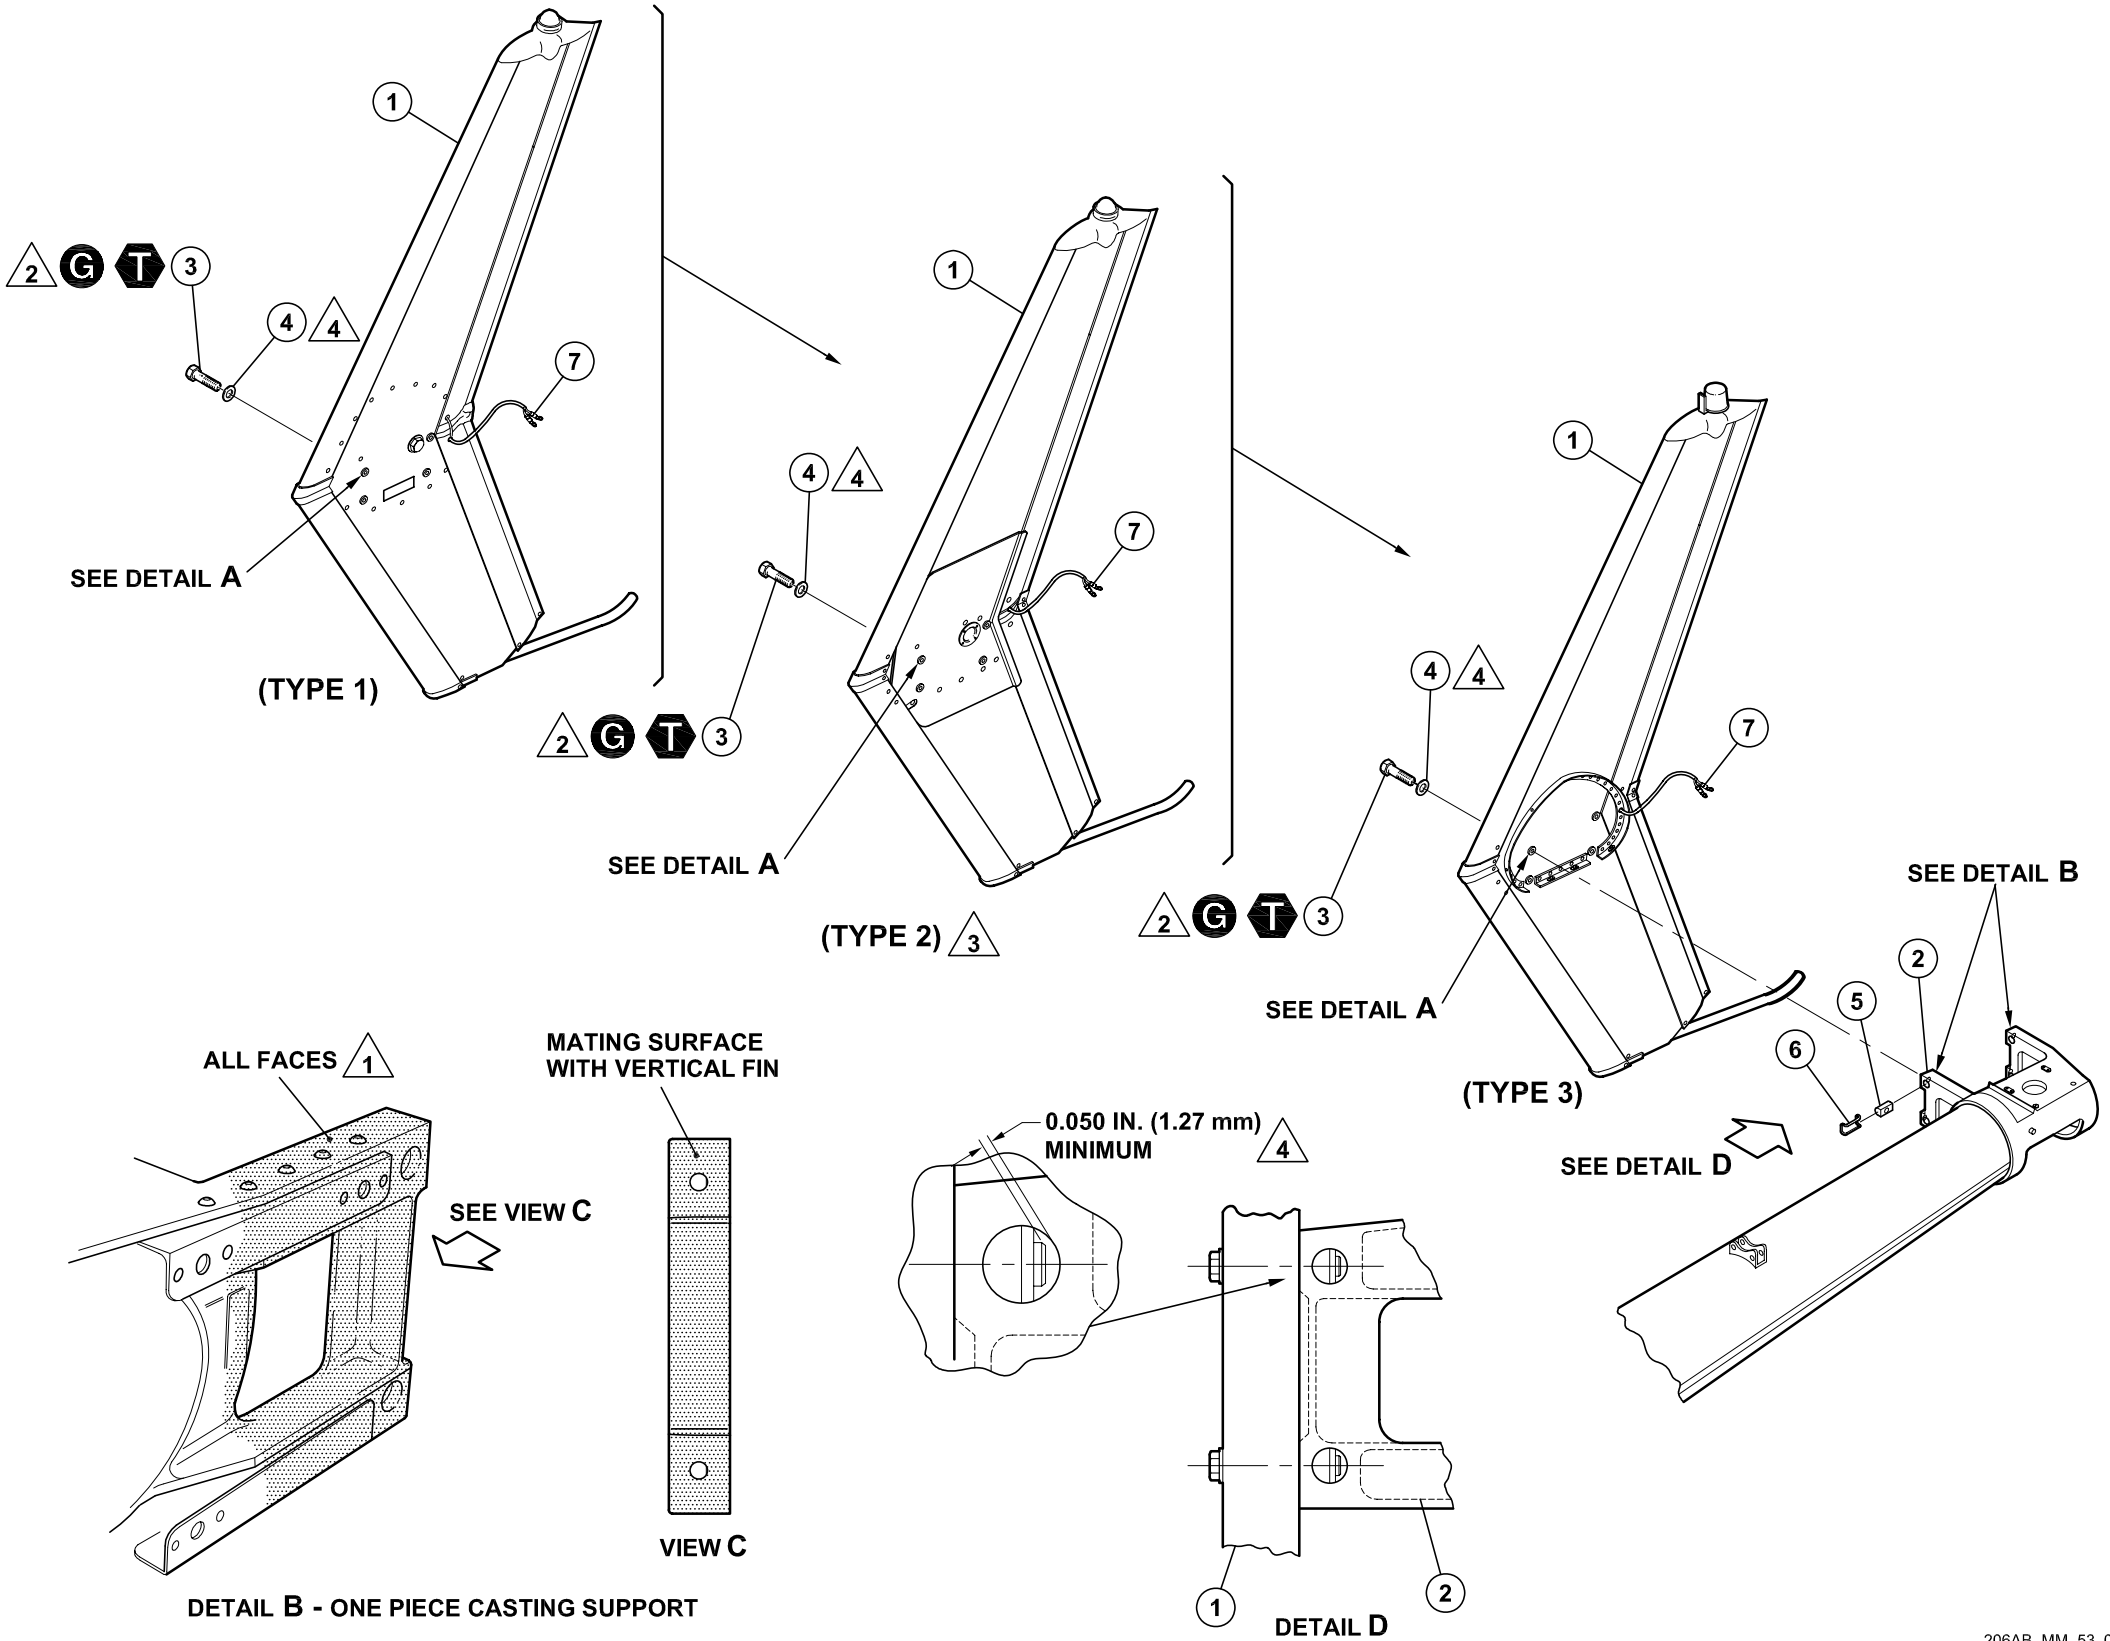
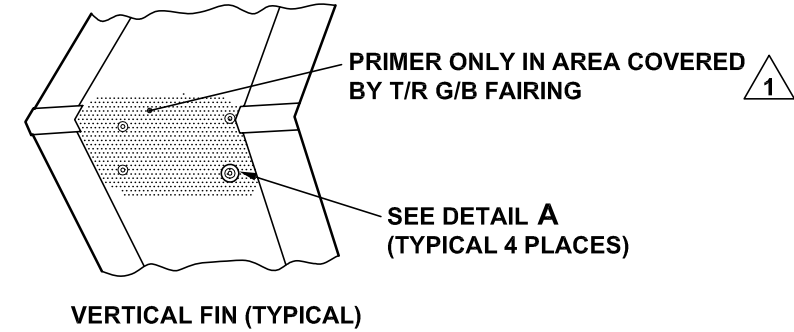
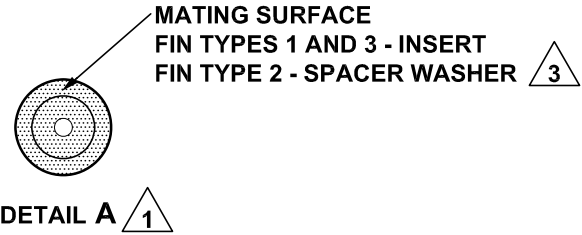
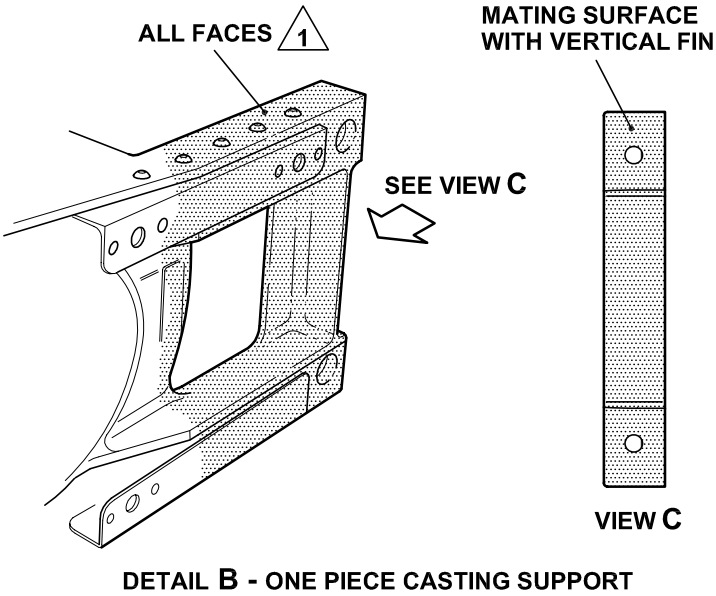
Figure 53-6. Vertical Fin Attachment to One-Piece Casting Support

- d. Remove vertical fin (1, [Figure 53-6](#)) from one-piece casting support (2).
- e. Put the vertical fin on a soft surface to prevent damage.

- 1** Surfaces to have primer coating only.
There shall be no paint coating.
- 2** Apply a coating of corrosion preventive coating (C-104) to shank of bolts prior to installation. Do not apply corrosion preventive coatings to threads of bolts.
- 3** As applicable to Type 2 fins only, ensure spacer washers are bonded to fin (4 places) prior to installation of fin. Refer to Figure 53-8.
- 4** To maintain 0.050 inch (1.27 mm) minimum gap between end of bolt (3) and surface of hole (view D), it is permissible to install 2 washers (4) (maximum) under head of bolt (3).

b. For vertical fins (1, [Figure 53-6](#)) installed on a one-piece casting support (2), ensure bolts (3) have a minimum torque check value of 75 inch-pounds (8.47 Nm).

3. Install the vertical fin (1, [Figure 53-6](#)) on one-piece casting support (2) as follows:

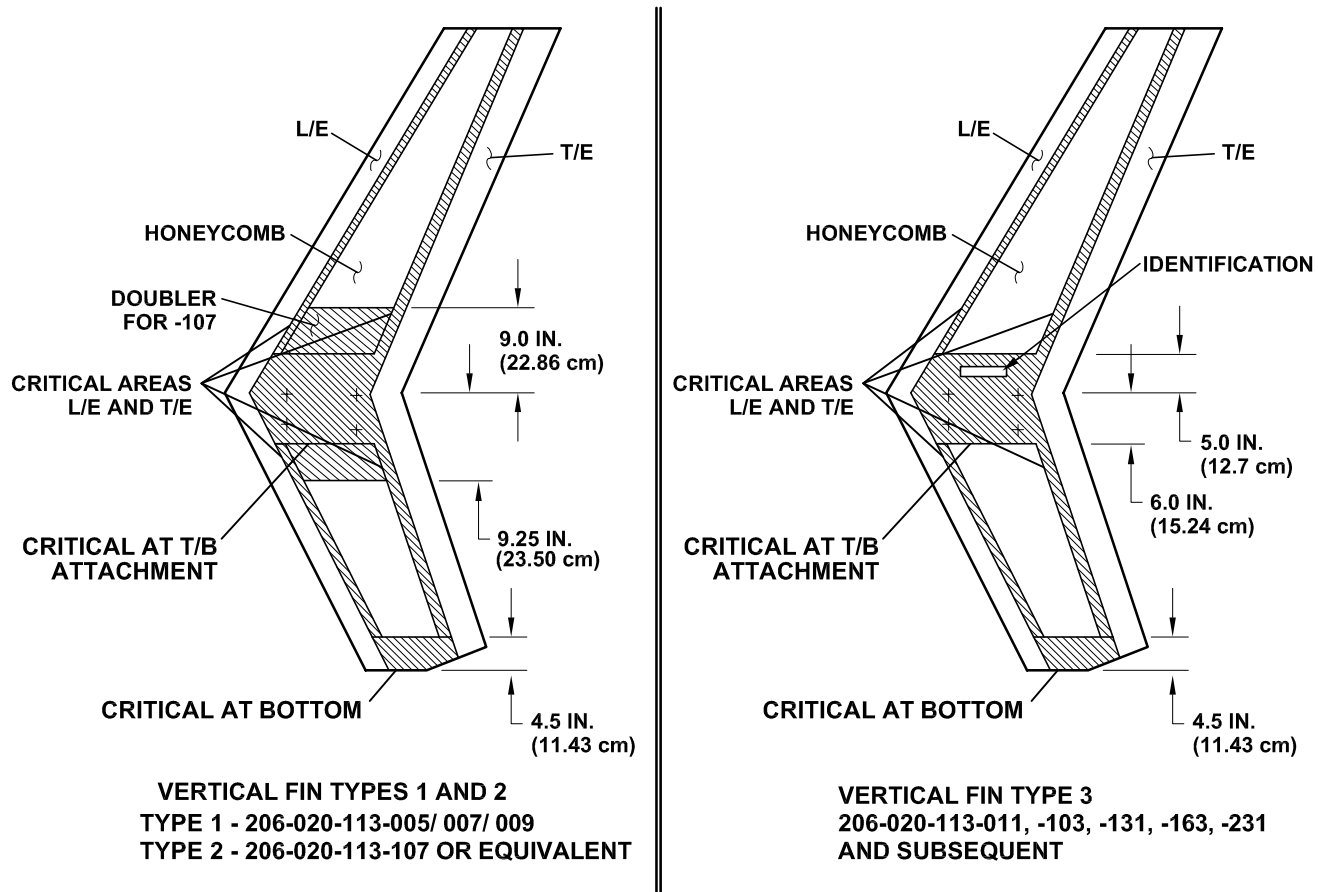
The Figure described below indicates repairable and restricted areas of the vertical fin. The restricted areas can be defined as follows:

- The area where the four attachment inserts are located (inboard and outboard).
- The area where the tail skid is attached to the fin.
- The areas where the leading edge and trailing edge caps are bonded to the honeycomb panel; total width 1 inch (25.4 mm) along honeycomb panel forward and aft edges.

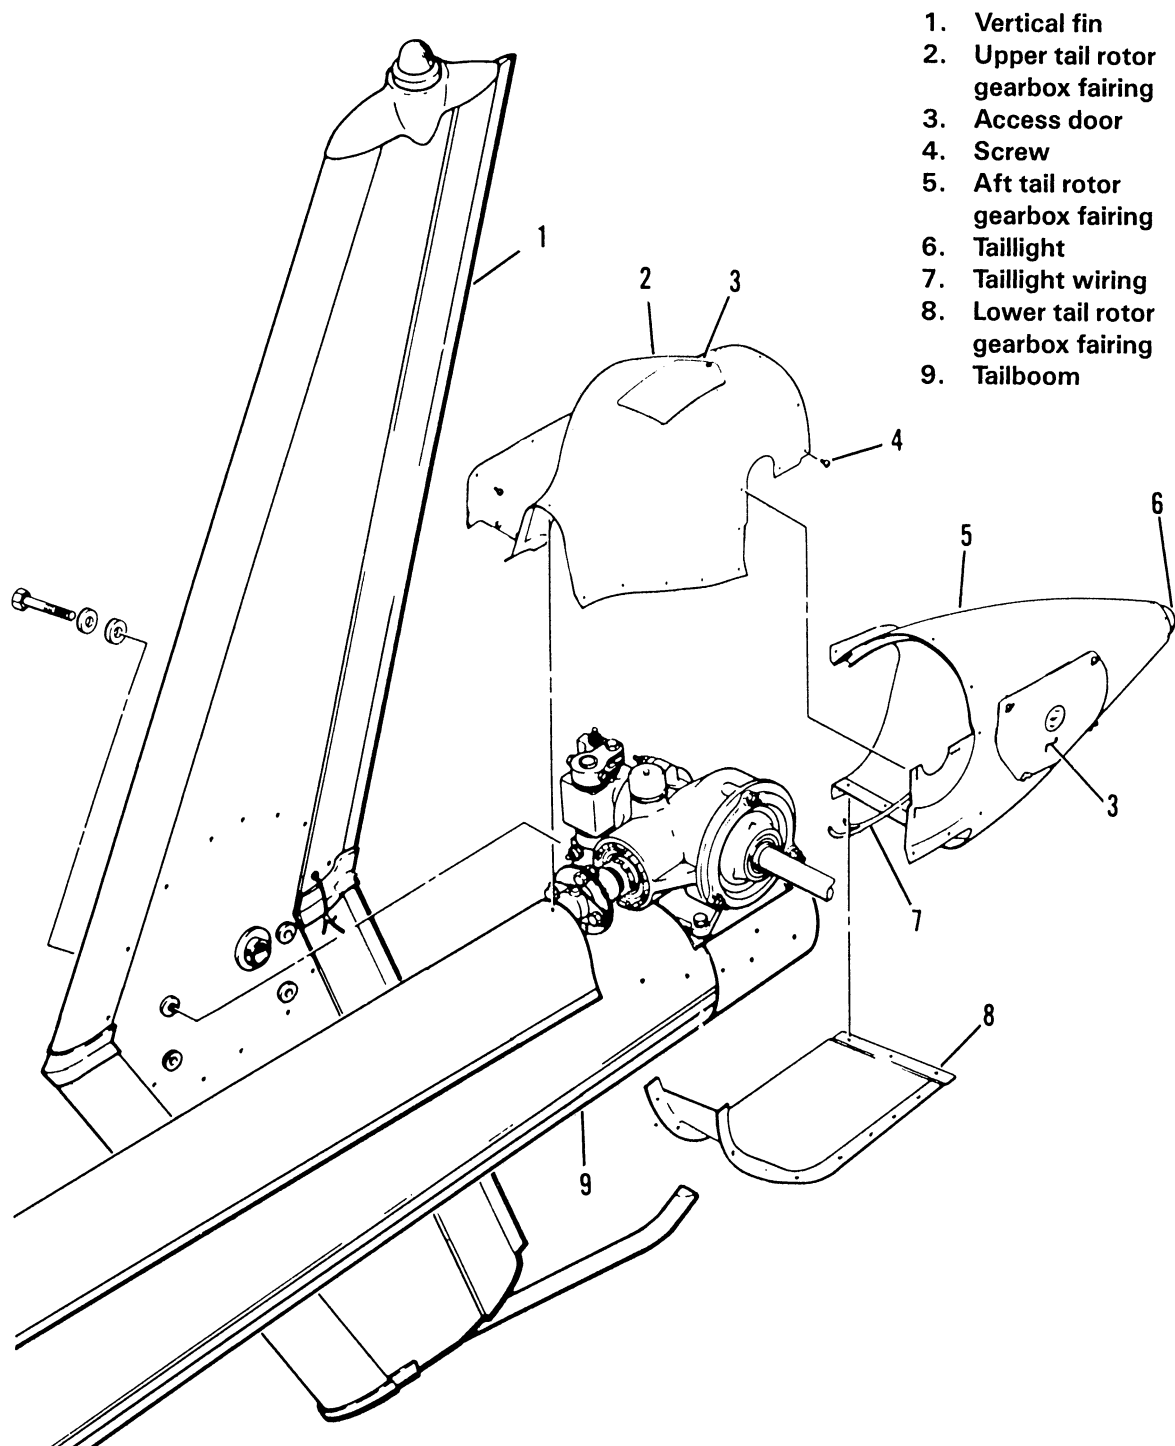
Figure 53-11. Tail Rotor Gearbox Fairing (S/N 4 through 1251)

HELICOPTERS 4 THROUGH 1251

1. Inspect tail rotor gearbox fairings (2, 5, and 8, [Figure 53-11](#), and 2 and 8, [Figure 53-12](#)) and access doors (3, [Figure 53-11](#)) for cracks, dents, distortion, and loose rivets. Inspect nutplates for looseness and damaged threads. Accomplish repairs in accordance with [BHT-206-SRM-1](#).

6. Inspect taillight (6, [Figure 53-11](#) and 3, [Figure 53-12](#)) for damage and security.

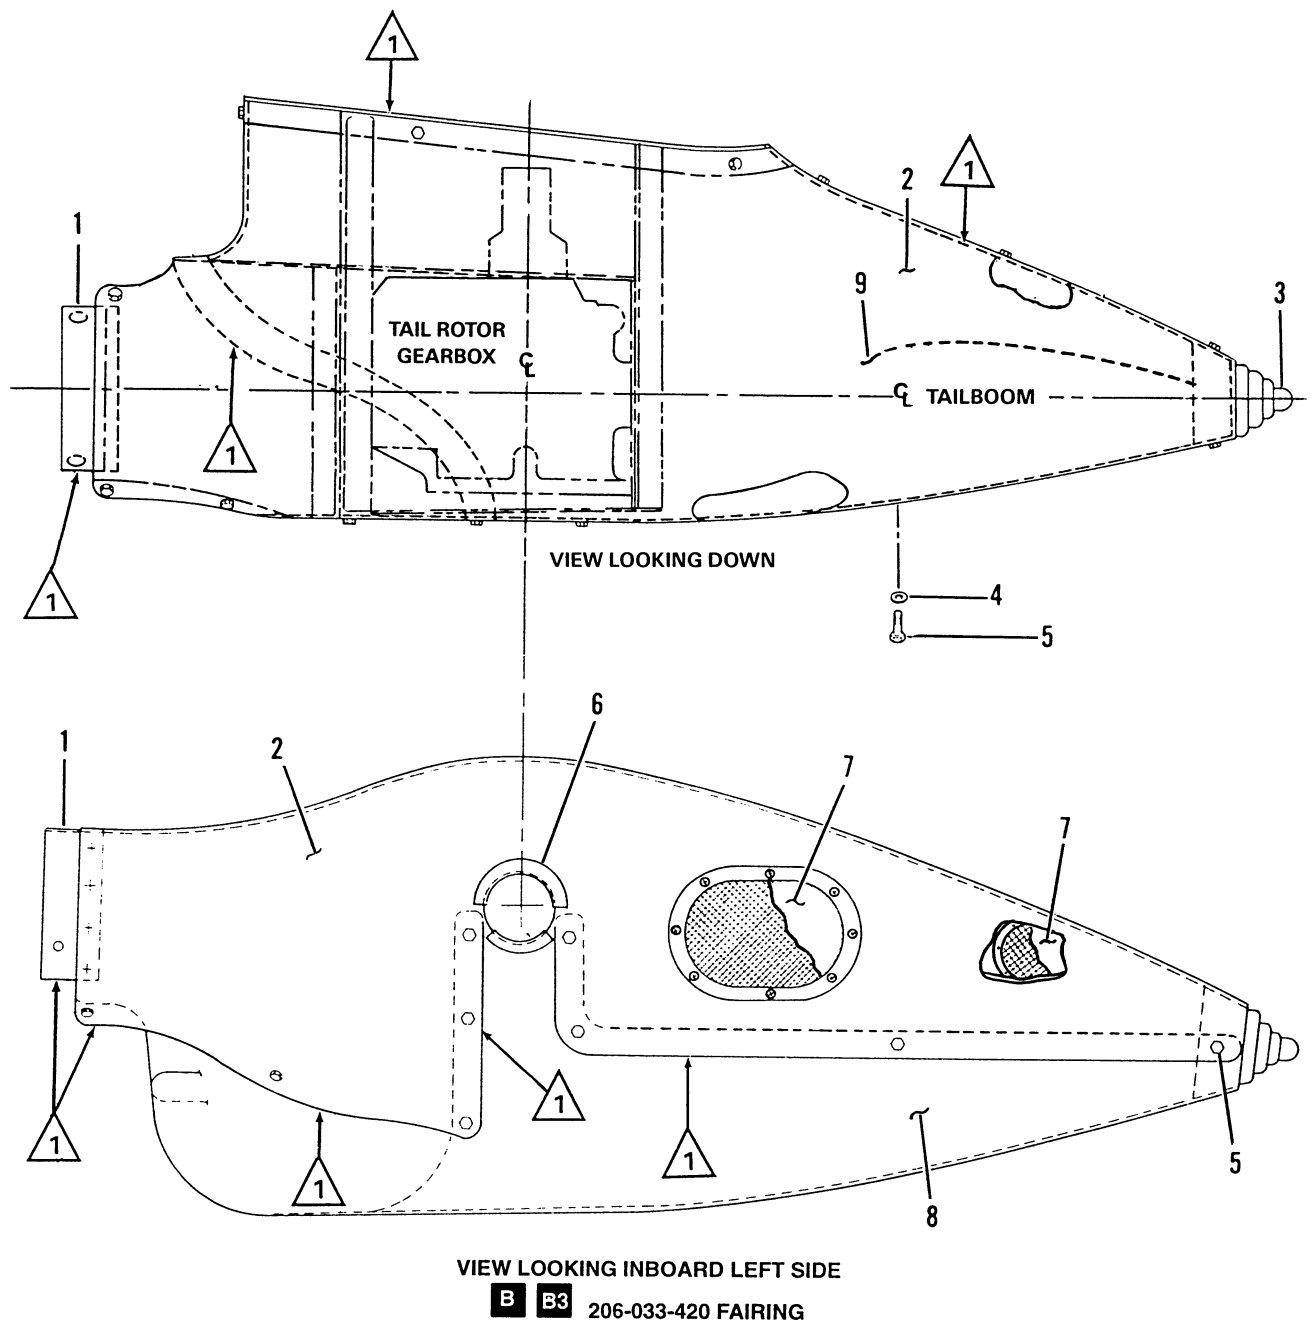
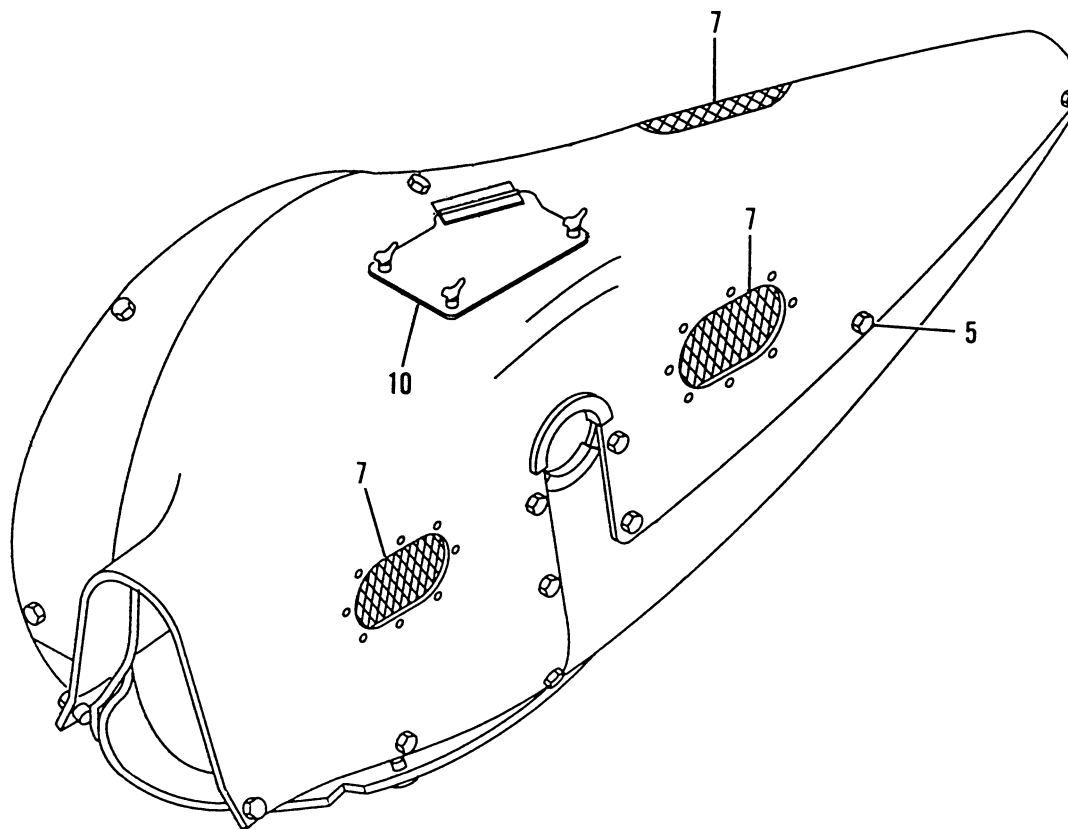
Figure 53-12. Tail Rotor Gearbox Fairing (S/N 1252 and Subsequent) (Sheet 1 of 2)

HELICOPTERS 1252 AND SUBSEQUENT

VIEW LOOKING INBOARD LEFT SIDE

2. Inspect rubber edge cover (6, [Figure 53-12](#)) for deterioration and security to fairings. If edge cover is loose or requires replacement, bond to fairings using adhesive ([C-325](#)).
