MD-80 AIRCRAFT MAINTENANCE MANUAL

CHAPTER 56 WINDOWS

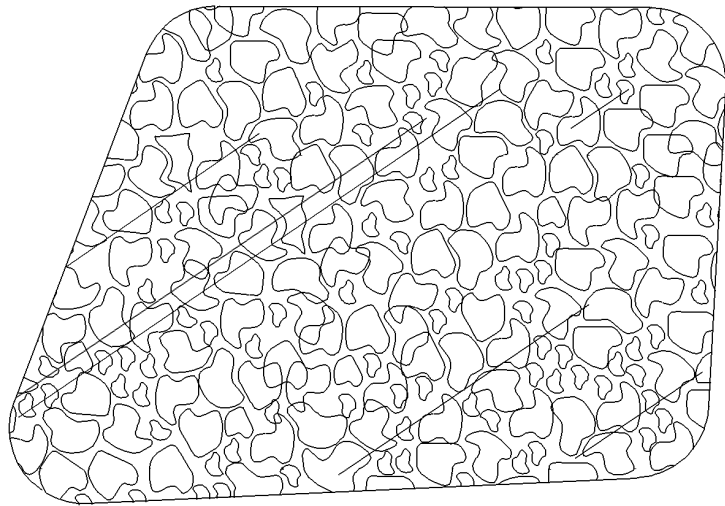
**GLASS PANE CRACKS
(SEMI-TEMPERED, OUTER/INNER PANE)**

**GLASS PANE CRACKS
(FULL TEMPERED, CENTER CORE PANE)**

**Windshield/Window Defect Zone Limits
Figure 601/56-00-00-990-801 (Sheet 4 of 7)**

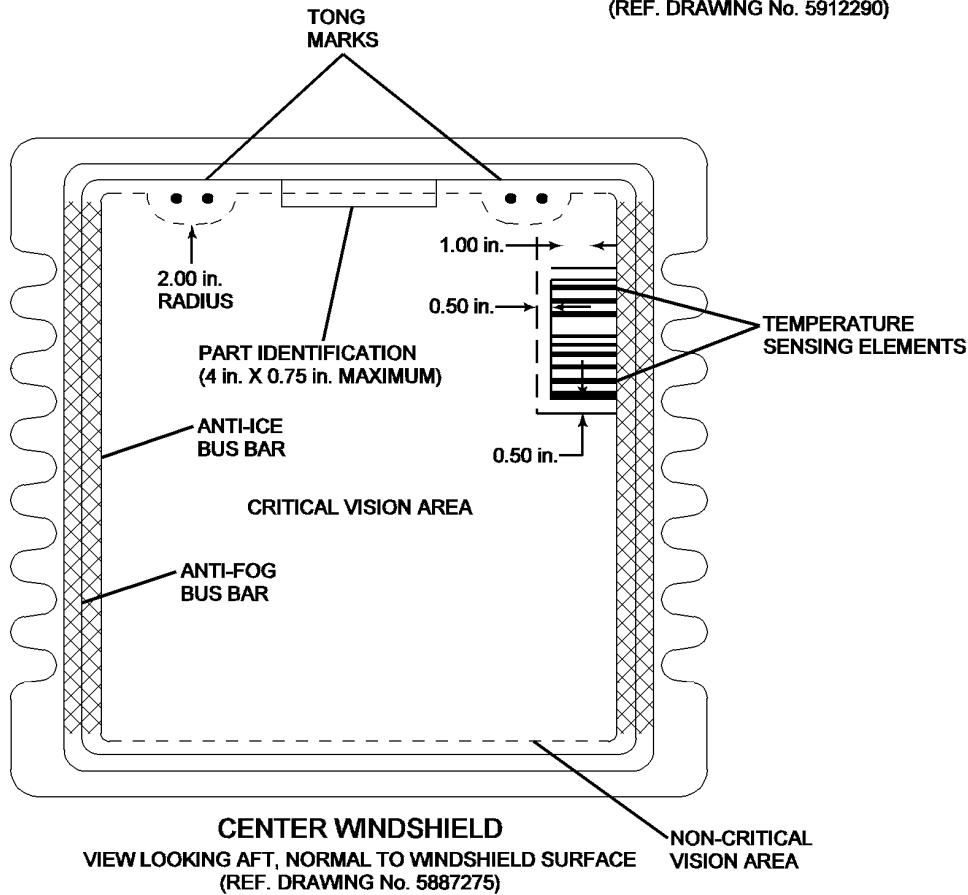
**Windshield/Window Defect Zone Limits
Figure 601/56-00-00-990-801 (Sheet 5 of 7)**

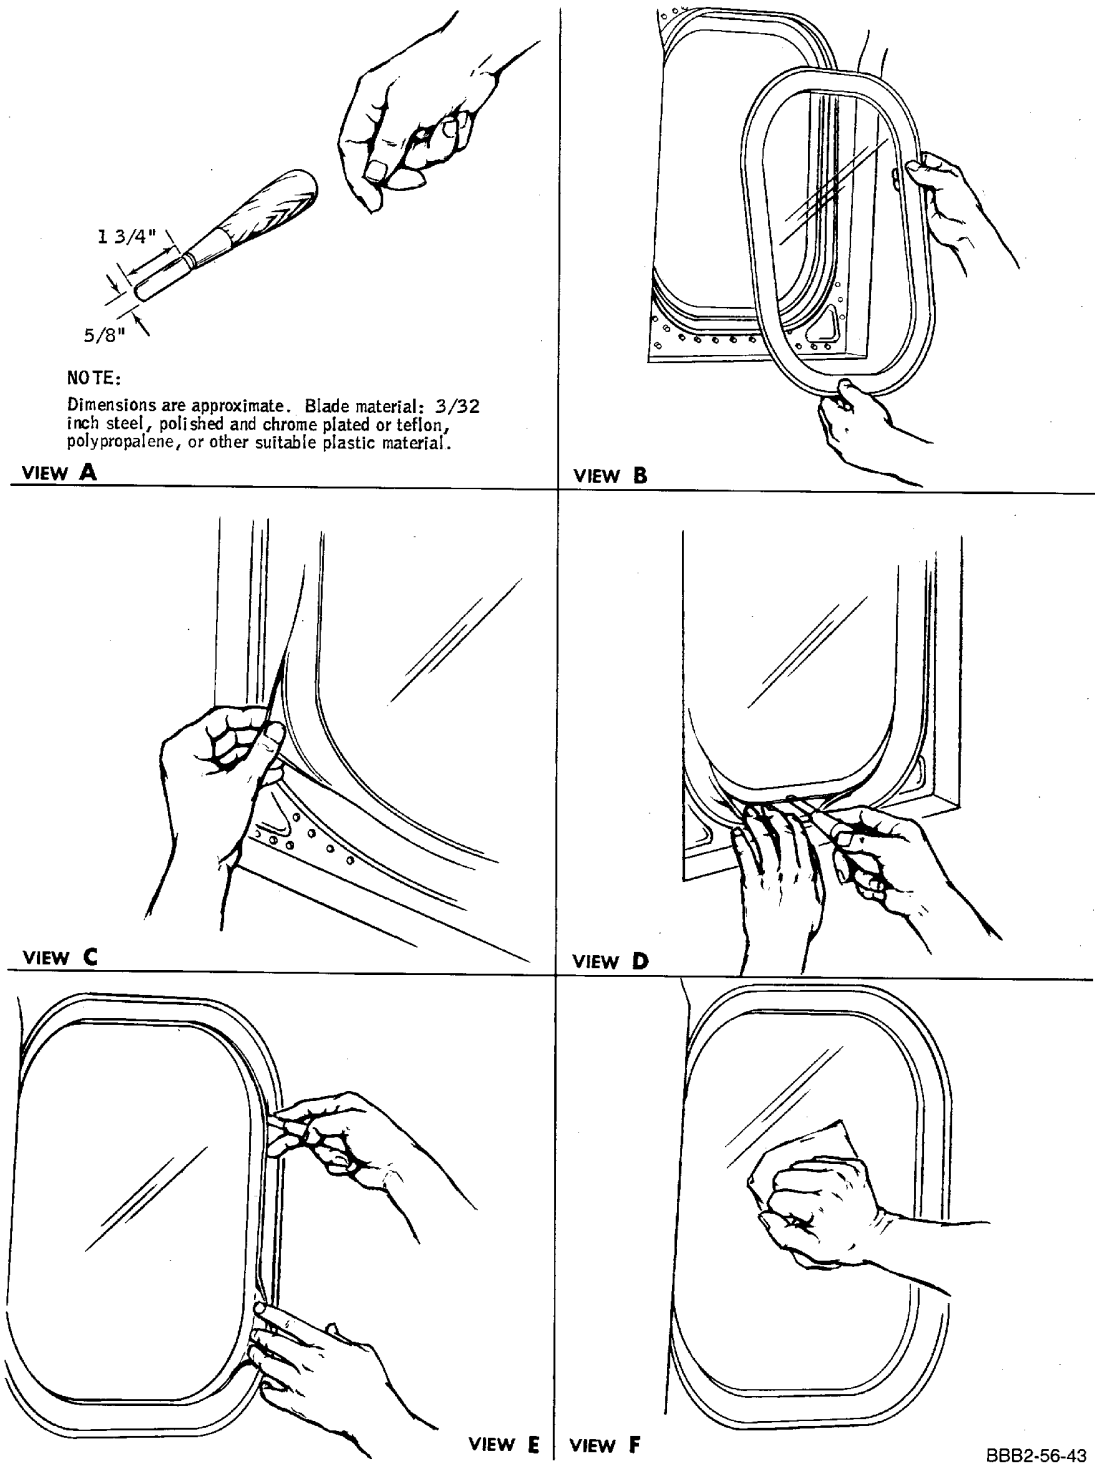
1 3/4"
5/8"

NOTE:
Dimensions are approximate. Blade material: 3/32 inch steel, polished and chrome plated or teflon, polypropylene, or other suitable plastic material.

- A. As an aid to installation, a simple tool may be fabricated to dimensions shown on Figure 201. All edges must be rounded and smooth. It is recommended that the blade be chrome-plated, if made of metal, to protect against tearing or cutting of seals.
